## **Floating booms to prevent blue-green algal scums and other floating debris from fouling Madison area swimming beaches: a pilot test**

Richard C. Lathrop, Wis. Dept. Natural Resources

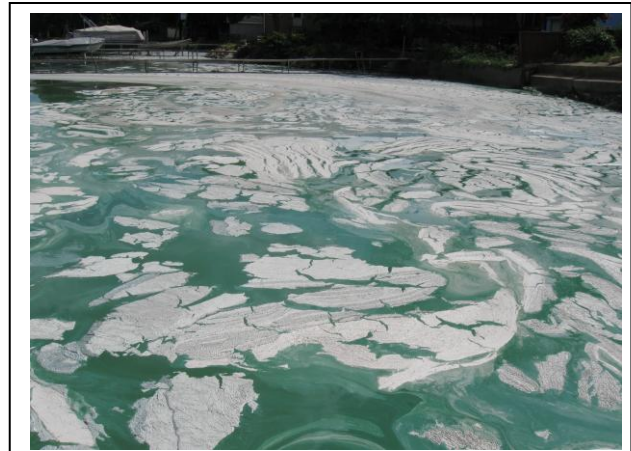
*Fig. 1. Blue-green algal scum on the Yahara lakes. (Lake Kegonsa, June 2012; Photo credit: Dane County Land and Water Resources Dept.)*

Excessive growths or “blooms” of blue-green algae (a.k.a. cyanobacteria) commonly occur during the summer months in the nutrient-rich Yahara lakes (Fig. 1). Such blooms are a serious health concern to humans and wildlife because certain species of blue-green algae can produce neurotoxins, skin toxins, and/or heptatotoxins leading to symptoms such as: liver and kidney lesions; and gastrointestinal, muscular, and respiratory symptoms including seizures and respiratory arrest.

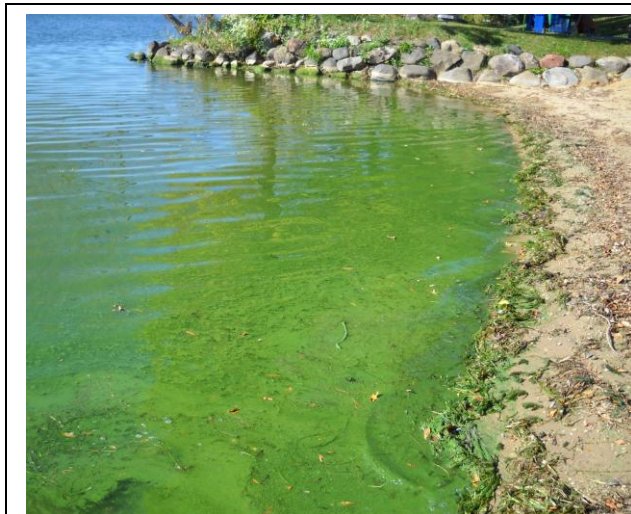
*Fig. 2. Algae pile-up in the protected shoreline cutout at B.B. Clarke Beach, Oct. 5, 2010. (Photo: G. Steinhorst, City of Madison Engineering Dept.)*

Besides scums and other floating debris piling up on the downwind shorelines of the Yahara lakes, the noxious material can also accumulate along other shorelines in protected backwater areas due to eddy formation from “long-shore” water currents moving laterally to the shoreline. Public beaches on the Yahara lakes are particularly susceptible to eddy formation and trapping material because many of the local beaches are constructed as tapered sand bottom cutouts into rip-rapped shorelines (Fig. 2).

deployment of the deflector boom system. Another algal bloom was present at B.B. Clarke Beach on October 5-6, 2010 after the boom system was removed (Fig. 2). Microcystin toxin concentrations found in this algal bloom were greater than the highest measureable concentration ( $>125 \mu\text{g/L}$ ) for a sample taken of the scum itself, and  $8 \mu\text{g/L}$  for a sample taken below the scum layer. (For reference,  $20 \mu\text{g/L}$  is the threshold limit established by the World Health Organization for microcystin health advisories in recreational waters.)

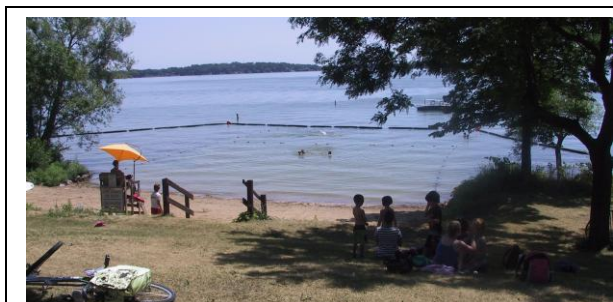
*Fig. 3. Three-sided, trapezoid-shaped deflector boom system deployed at B.B. Clarke Beach during June-August 2010-2012. (Photo: R. Lathrop, WDNR)*

Boom system design. Each boom system consisted of three individual boom walls connected to form three sides of a trapezoid surrounding a beach’s swimming area (designated by floating ropes) with the much wider “base” of the trapezoid being the park shoreline extending beyond each side of the sand beach (Fig. 3). Thus, the shorter endwall boom of the trapezoid was deployed parallel to shore just beyond the roped swimming area. The two longer sidewall booms were designed to ideally attach at the park shoreline with an approximate 120-degree angle on the outside

corner of the trapezoid. This design allowed the obtuse-angled sidewall boom when subjected to long-shore currents to “deflect” floating material away from the beaches and out into the lake. During other times, floating material would be temporarily trapped outside the boom near shore.

**B.B. Clarke Beach.** The 3-sided deflector boom system worked well at B.B. Clarke Beach (Figs. 3, 6) during all three summers of boom deployment in 2010-2012 because this beach is often exposed to long-shore water currents (Fig. 7). Beach users and lifeguards during informal interviews felt the beach was much cleaner with high public acceptance of the boom system. However, in 2010 the popular diving platform was not installed in deeper water beyond the boom endwall due to concerns that lifeguards could not easily traverse the boom wall if an emergency occurred. Experience showed that the boom wall was not a barrier (even acting as a safety float) such that diving platform was installed in subsequent summers.

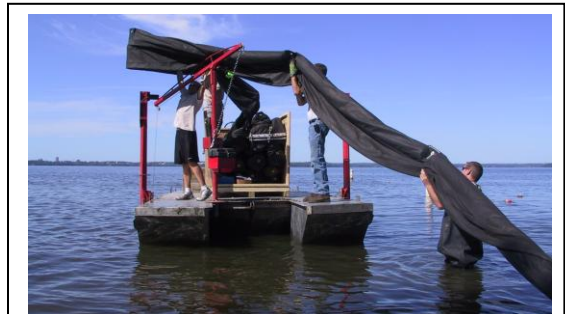
*Fig. 4. Boom wall being unloaded from a barge, June 2012. (Photo: R. Lathrop, WDNR).*

Each boom wall was constructed of 8 oz. Polypropylene Geotextile fabric. The boom wall’s flotation collar consisted of a series of 10-foot long styrofoam tubes (6-inch diameter) covered by a double layer of fabric for extra durability (Fig. 4). A hanging fabric curtain weighted with ballast chain extended one foot below the flotation collar to ensure good interception of floating debris in the lake while allowing water to circulate freely underneath the boom. This design prevented water from stagnating within the swimming area. During windy periods with strong waves and water currents, the curtain would “billow” sideways thereby reducing pressure on the boom wall. A stainless steel tension cable in the curtain directly underneath the flotation collar allowed each boom wall to be tightly stretched in a straight line between two anchoring points on the shoreline and/or in the water.

Boom installation. Deploying each boom system required a barge and a boat plus crew from Dane County (Fig. 4). After unfurling a boom wall from the barge, the shore end of each sidewall boom was attached by chain to a large tree, rip-rap boulder, or installed iron tie-down rod on shore. In the lake, the two sidewall booms were connected to the endwall boom by bolting the respective fabric curtain edges together to form a tight seal at each corner. Then the two boom tension cables on the outside of each boom corner were attached to a large floatation barrel. Ropes attached to each corner barrel allowed the barge and boat to stretch the 3-sided boom system to its full size. Heavy concrete block anchors were then placed in deeper water some distance away from the corners in the general direction of a perpendicular bisector of each corner angle to equalize the tension on the two boom walls. Finally, the anchors were attached by a long chain to each floatation barrel with full tension put on the boom system to ensure all three boom walls were straight while the floatation barrel prevented the boom corner from being pulled underwater. For safety, navigation hazard buoys were attached to each anchor chain.

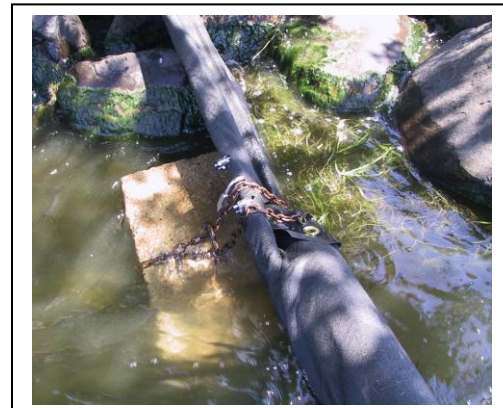
*Fig. 5. Concrete block and chain used to prevent boom wall from being lifted out of lake at shoreline. (Photo: R. Lathrop, WDNR)*

Because the shoreline attachment point was usually well above the waterline, the boom wall tended to lift out of the lake near shore. That problem was rectified by placing a heavy block at the water’s edge and chaining the boom’s tension cable downward to the block at a point right next to the edge of the first floatation tube (Fig. 5). A 5-ft piece of geotextile curtain fabricated on each sidewall boom’s shore end helped ensure a tight seal at the shoreline to prevent floating debris from leaking into the swimming area.

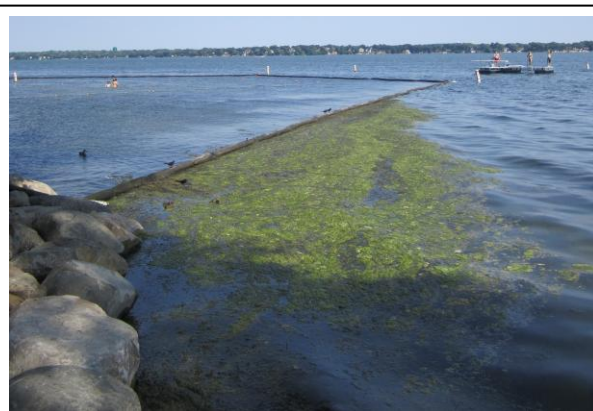
*Fig. 6. Photo showing the deflector boom system preventing algae scums and other floating debris from entering the enclosed swimming area at B.B. Clarke Beach, June 2012. (Photo: C. Betz)*

In addition to these results, a graphic photo taken in June 2012 showcased how the western sidewall boom prevented algal scums and other floating debris from entering the swimming area (Fig. 6). The floating material was trapped in the southwest corner of the boom at shore. No health advisory was posted at the beach during this period and the trapped debris later left the area. Time-elapsed photos taken every 5 minutes for a period of 90 minutes during mid-July 2010 also showed how floating debris interacted with the same boom subjected to long-shore currents. In the sequence of photos, a mass of floating aquatic plants was filmed moving along the deflector sidewall boom to its end where the plant mass was released into deeper water.

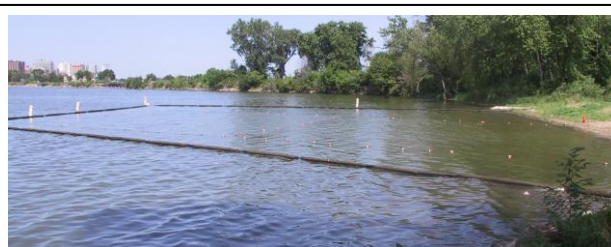
*Fig. 8. Deflector boom system deployed at Bernie's Beach, June-August 2010-2011. (Photo: R. Lathrop, WDNR)*

**Bernie's Beach.** The deflector boom system deployed at Bernie's Beach (Fig. 8) during the summers of 2010-2011 maintained the swimming area relatively free of algal scums and other floating debris. Because of the more sheltered and restricted location of the beach area in the corner of Monona Bay, the two sidewall booms were attached to shore with outside wall angles only slightly greater than 90 degrees. Floating material was often observed trapped outside the corner of the west sidewall boom (Fig. 9).

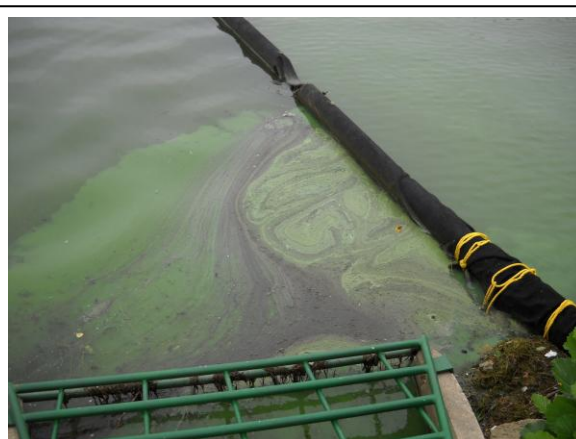
*Fig. 9. Algae scum and other floating debris trapped outside the sidewall boom at Bernie's Beach, July 2010. (Photo: G. Steinhorst, City of Madison Engineering Dept.)*

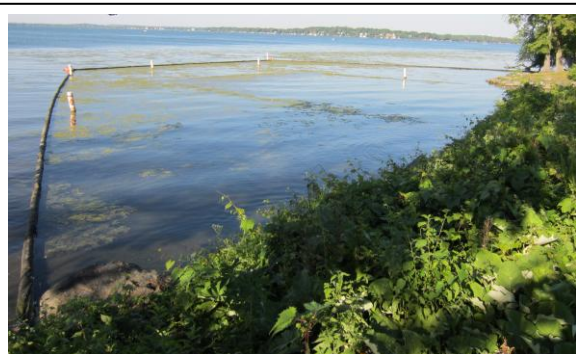
*Fig. 10. Deflector boom system deployed at Olin Beach in 2012 showing aquatic plants and filamentous algae growing inside and outside the boom system. (Photo: R. Lathrop, WDNR)*

Olin Beach. The deflector boom system tested at Olin Beach on Monona's southern shoreline in 2012 did not work particularly well even though the boom system itself was a good fit for the beach (Fig. 10). The main problem was the swimming area inside the boom system was very shallow with a significant amount of aquatic plants and filamentous algae growing from the lake bottom. Some effort was made to clear out this area with a weed harvester prior to installing the boom, but the filamentous algae quickly grew back into thick masses that created unappealing swimming conditions at the beach. This southwest beach shoreline often was on the upwind end of the lake where water currents could not remove the floating material trapped outside of the boom walls.

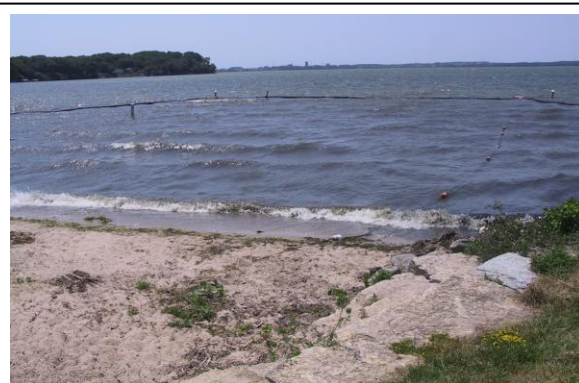
*Fig. 11. Deflector boom system deployed at Warner Beach in 2012. (Photo: R. Lathrop, WDNR)*

**Warner Beach.** A new deflector boom system was tested at Warner Beach in 2012 (Fig. 11) as the location presented some challenges that were different from the other beaches tested during the previous two years. First, during prevailing southwesterly winds, Warner Beach on Mendota's northeast end had a very long fetch (the longest distance that waves travel unobstructed) and hence subjected to high waves and strong water currents. Modeling of water currents in Warner Bay indicated large opposing gyres of water currents (i.e., one circulating clockwise and one circulating counterclockwise) occur in the bay near the beach shoreline (Fig. 12). Thus, floating debris potentially could be intercepted by either or both sidewalls of the boom system prior to the surface water currents leaving the bay. These water circulation patterns helped explain why floating material sometimes accumulates in large amounts at Warner Beach (Fig. 13).

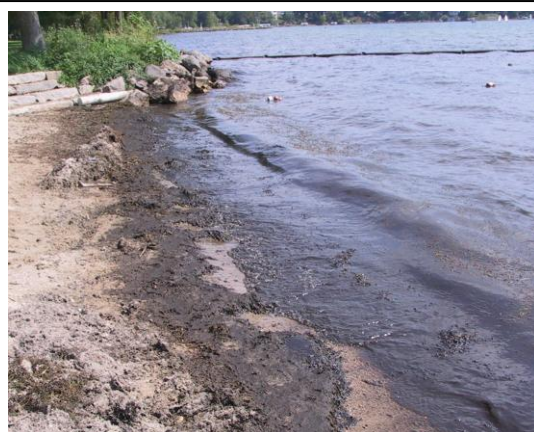
*Fig. 13. Suspended debris in the water and on shore inside the deflector boom system at Warner Beach in late July 2012. (Photo: R. Lathrop, WDNR)*

While blue-green algal scums were not a problem in Lake Mendota in summer 2012, decaying filamentous algae material originating from shallow areas all over the lake was particularly dense along the Warner Bay shoreline. This unaesthetic detrital material had entered the boom system and become trapped as a thick dark brown mass of suspended rotting sludge in a zone extending a few feet from the beach shoreline (Fig. 13). The park shoreline farther to the east also had this same sludge for a number of weeks, but the boom system likely would prevent the suspended material from leaving the beach when exposed to high winds.

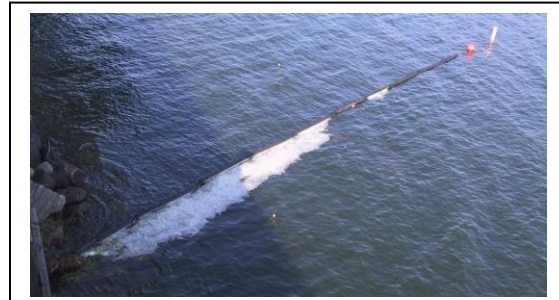
*Fig. 14. Floating material trapped on the single boom deployed at UW Center for Limnology in 2010. (Photo: R. Lathrop,*

Single boom test (UW-Madison shoreline). The single boom tested at the UW Center for Limnology shoreline in 2010 (Fig. 14) was deployed with a 60 degree angle on the west side of the boom to trap material coming from that direction. However, floating material occasionally became trapped for short periods on the obtuse-angled side of the boom wall; material was rarely trapped on the boom side facing University Bay. While large scums did not occur in Lake Mendota during 2010, this test demonstrated that a single boom could intercept and temporarily trap floating material especially along shorelines subjected to long-shore currents.
